Frequently asked questions #8

What is 'crevice corrosion'?

Interfacial Corrosion: Theory and practice

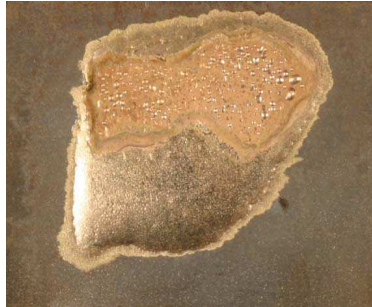
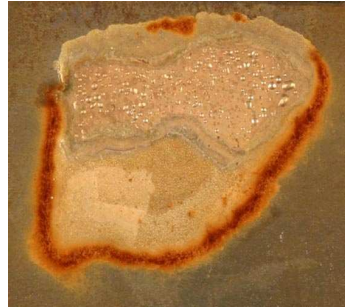
(a) Sample A before testing

(b) Sample A after testing

Fig 1(a): The thin line of a brown deposit at the edge of the brazing alloy that has formed in the **after** testing picture is a sure sign that the interface between the filler metal and the stainless steel is being attacked by 'interfacial corrosion'

In the examination of joints that have failed by the mechanism of crevice corrosion it is usual to find that the mating surfaces of it appears bright and un-pitted, as though the joint had never been properly brazed. A further distinguishing characteristic feature of this mode of failure is the appearance of a thin 'deposition' of what appears to be conventional 'rust' along portions of the periphery of the filler metal fillet on the joint. See **Figs 1(a) & 1(b)**

One of the most interesting features of **Figs 1(a) to (c)** is the fact that filler **Sample B**, the one that contains a small amount of nickel in addition to both cadmium and zinc, is slightly less prone to attack than the nickel-free **Sample A** material. This seems to point to the possibility that the presence of nickel in a filler material **retards** the on-set of interfacial corrosion. This *might* explain the passing references in texts, initially written in the 1960's, that such materials are acceptable for use where joints in austenitic stainless steels are to be brazed, and where the resultant joints will be exposed to conditions where interfacial corrosion will be a service hazard. Be that as it may, the author of this Paper would **not** be happy to have a brazed austenitic stainless steel plumbing system installed in his home if the chosen filler metal that was to be used for the installation was other than the **Sample C** material!!

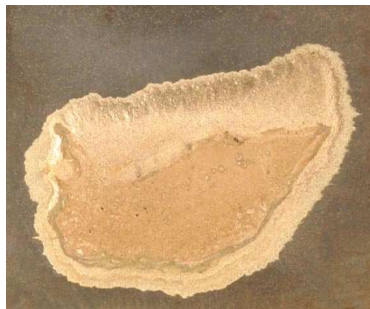
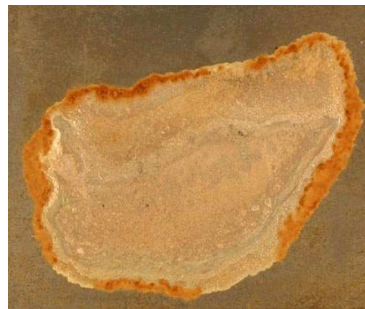
(b) Sample B before testing

(b) Sample B after testing

Fig 1(b): Here again the **after** testing sample shows evidence of interfacial corrosion attack. However the level is much lower than that experienced by **Sample A**. This is due to the presence of Nickel in **Sample B**, but note that **attack has still occurred!**

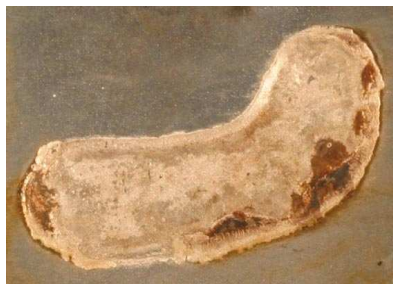
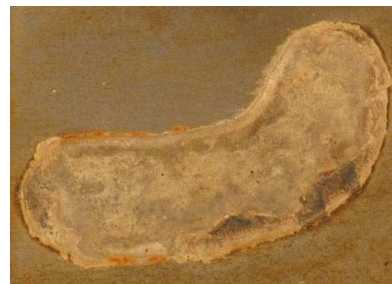
Sample C before testing

Sample C after testing

Fig 1(c): There is no evidence of interfacial corrosion in the '**after testing**' condition of **Sample C**, the very thin streak brown at the base of the alloy 'pool' and on its surface is mainly due to presence of manganese in the filler material: this is also visible in the '**before testing**' picture!

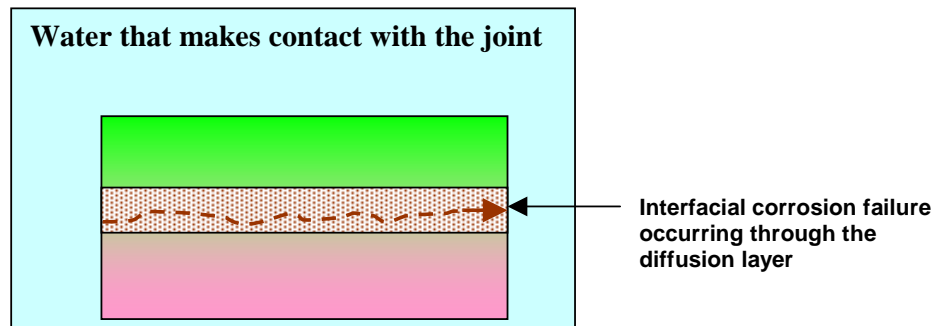
Fig 2(b): Interfacial corrosion failure through the layer of intermetallic compounds
